MERRIMACK RIVER BASIN
MERRIMACK, NEW HAMPSHIRE

MERRIMACK VILLAGE DAM

PHASE I INSPECTION REPORT
NATIONAL DAM INSPECTION PROGRAM

FEBRUARY 1979

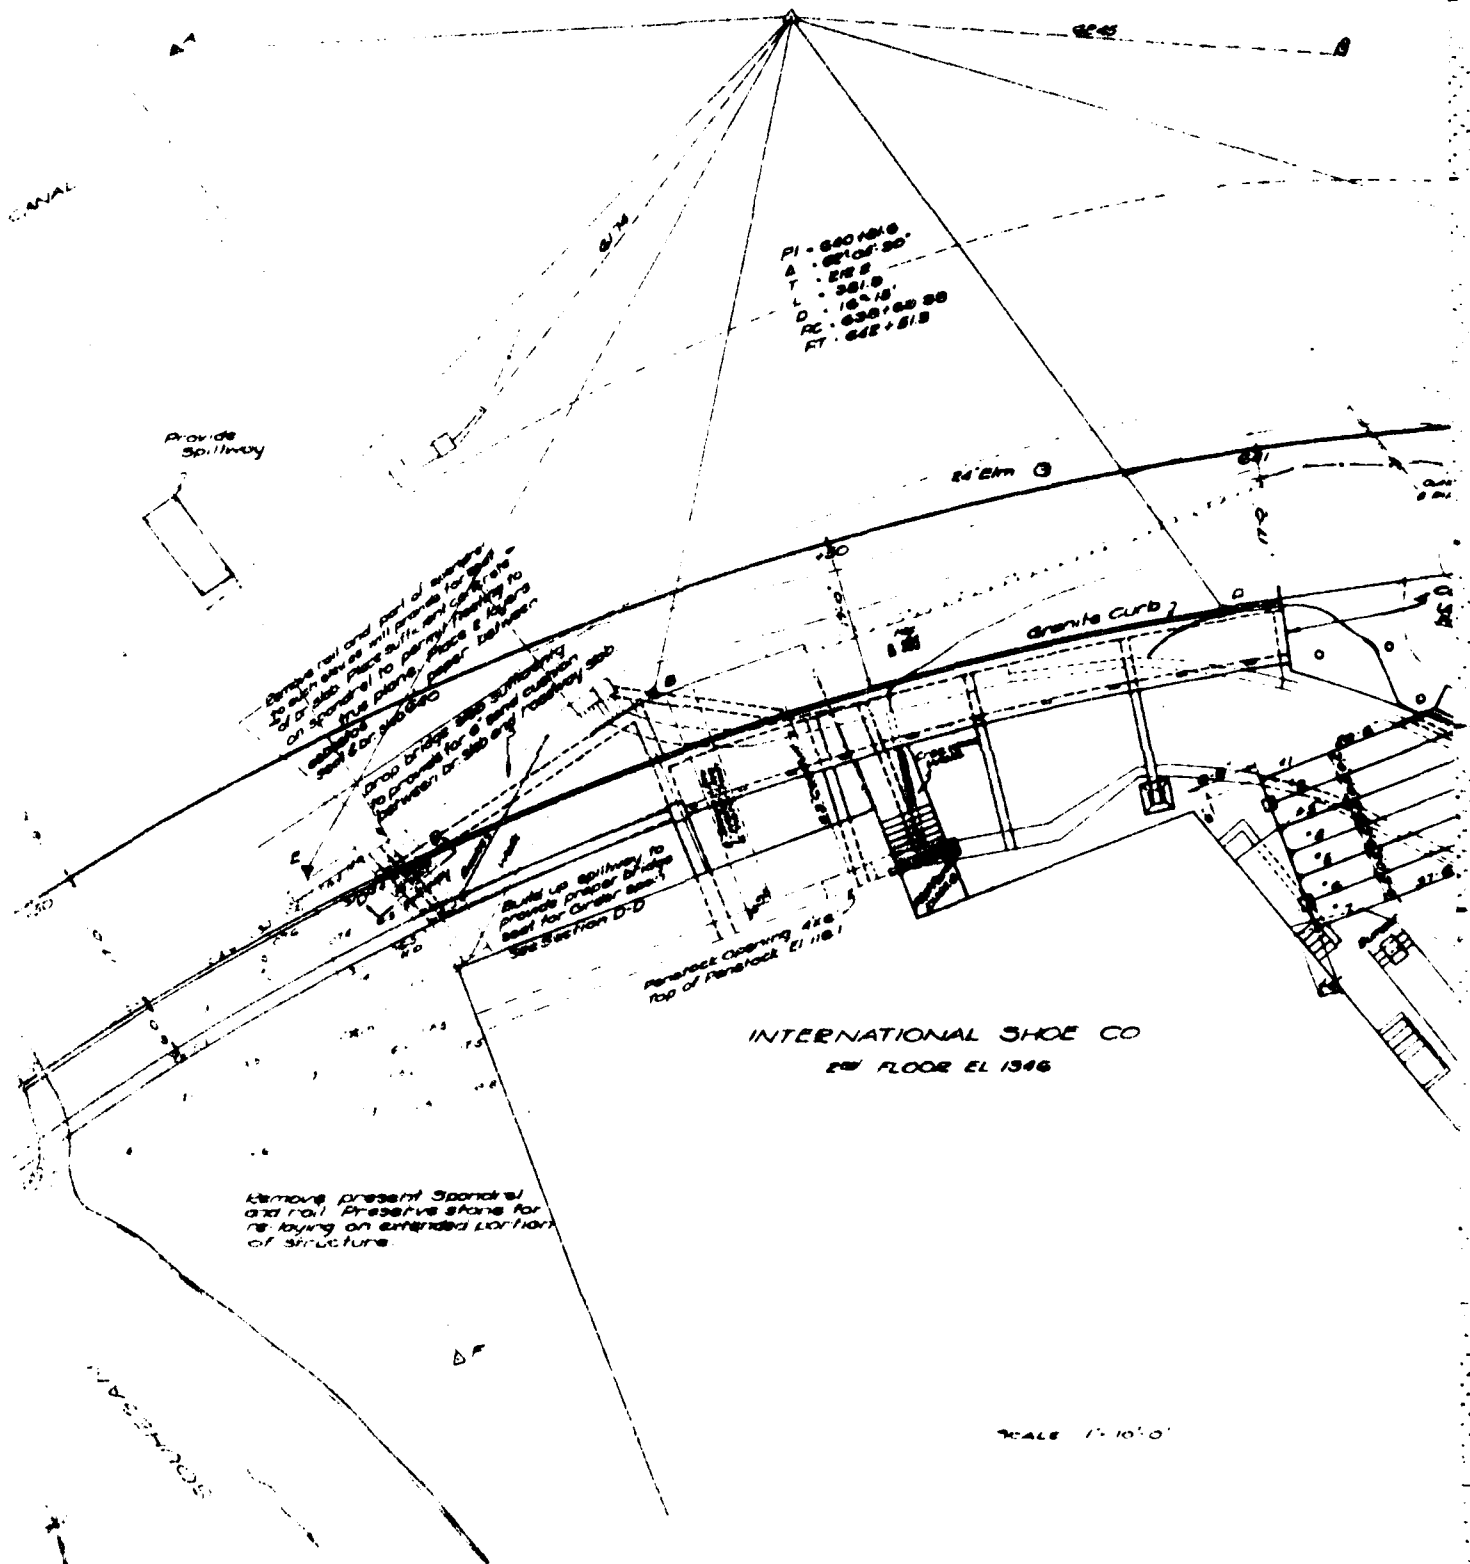
Build up abutment
provide proper
seat for other
see Section

Remove present Spandrel
and rail. Preserve stone for
re-laying on extended portion
of structure
